Manhole Inspection Summary

Manhole # S11QQ1018MH

Location Address: **REAR- 4900 CHALGROVE AVE**

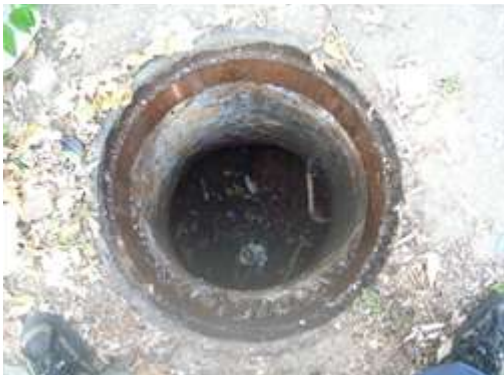
Top View

Offset: **1.5** (in.)

FRAME OFFSET

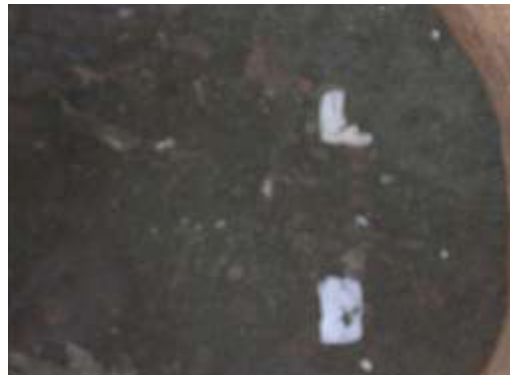
Defect 1

DEBRIS ON CHANNEL

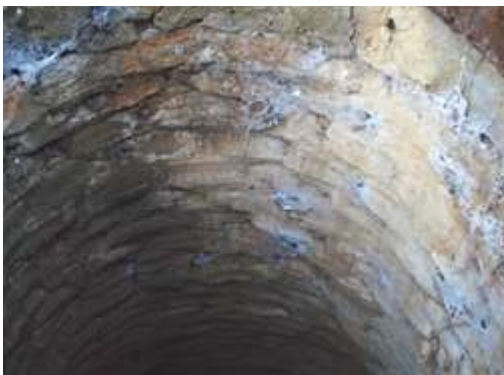
Defect 2

☒ **Evidence Of Surcharge** Depth: **2** (ft.) ☐ Active Surcharge Present

SURCHARGE EVIDENCE

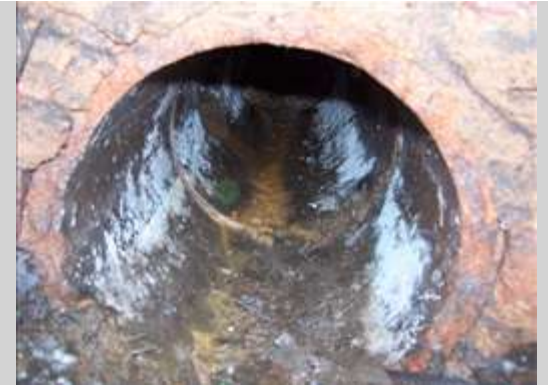
12 O'Clock Outflow

8 in. Circular Gravity Sewer
Pipe Out @ 12 O'Clock

Deposits: ☐ None ☐ Mud ☐ Sludge ☒ **Debris** ☐ Grease

Silt Depth: **1** (in.) Deposits Extent: **Light**
